Remediating and Monitoring White Phosphorus Contamination at Eagle River Flats (Operable Unit C), Fort Richardson, Alaska

FY07 Data Report

Susan R. Bigl and Charles M. Collins, Report Editors

May 2008

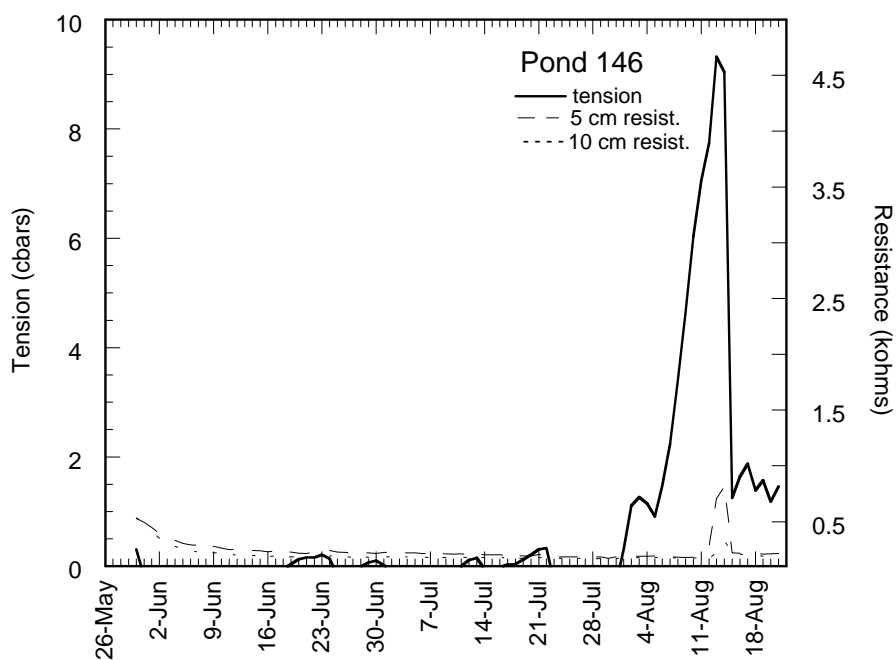
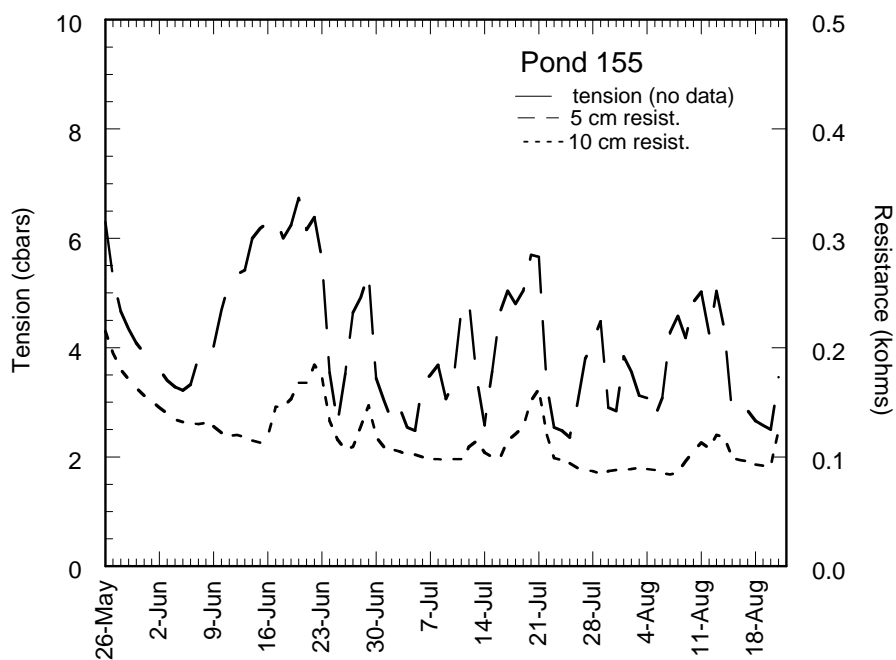
**a. Pond 146.**

**b. Pond 155.**

Figure III-2-10. Output from moisture sensors during the summer of 2007. Increases in tension and resistance indicate the sediment was drying.

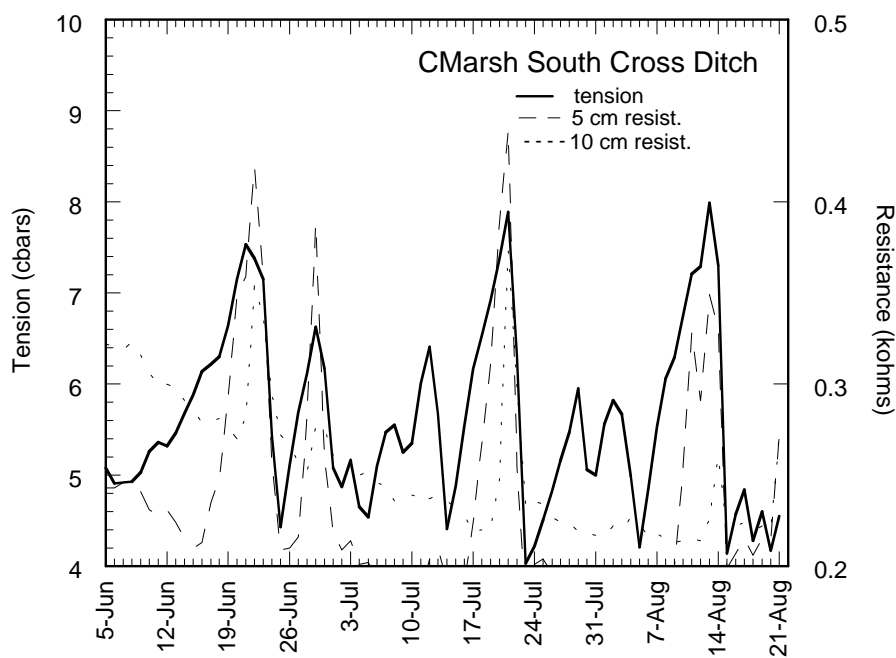
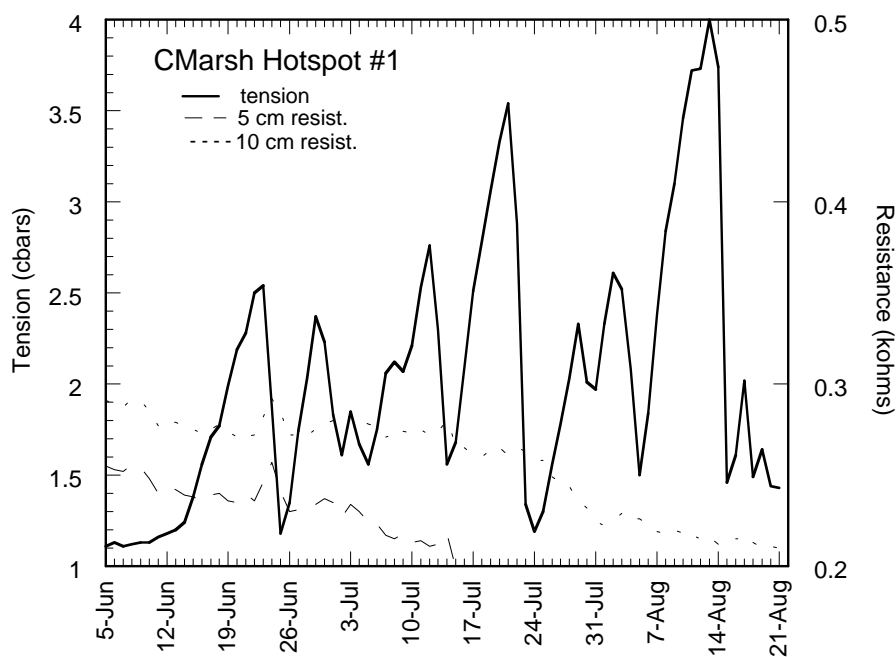
c. C Marsh South (Ditch).

d. C Marsh Hotspot #1 (03DIS38).

Figure III-2-10 (cont.). Output from moisture sensors during the summer of 2007. Increases in tension and resistance indicate the sediment was drying.

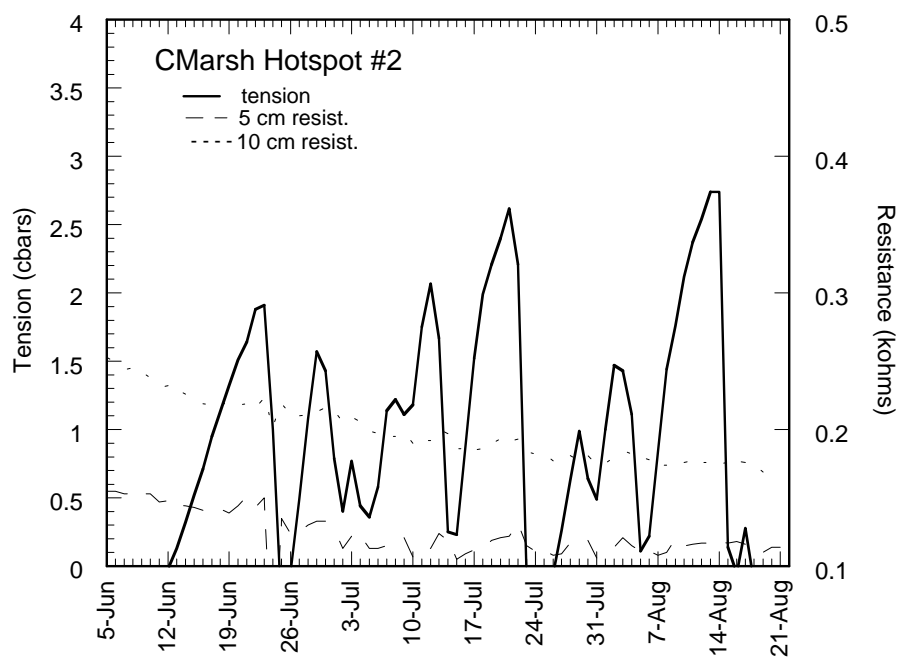
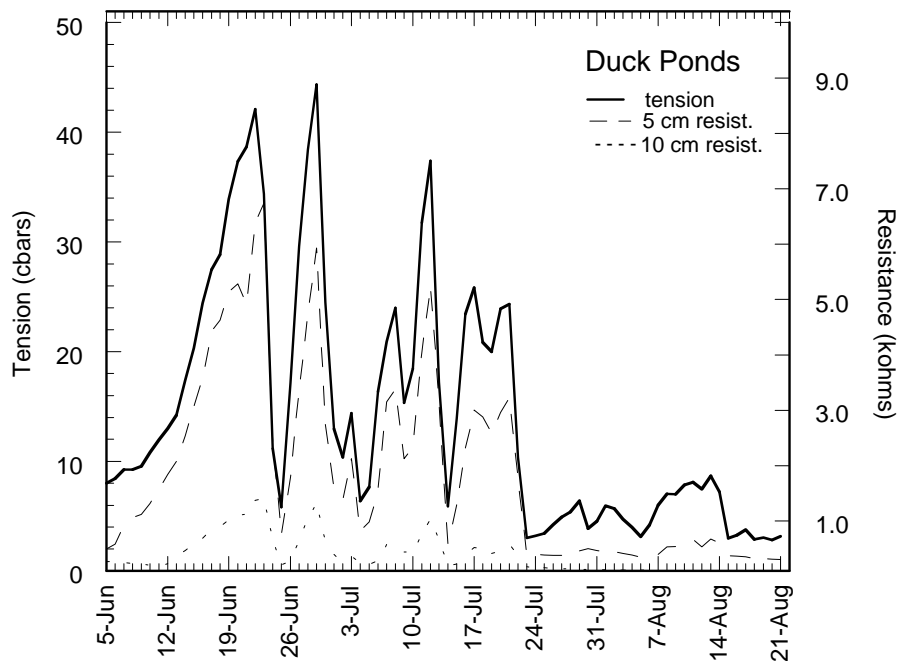
e. C Marsh Hotspot #2 (03DIS42).

f. Duck Ponds.

Figure10 (cont.). Output from moisture sensors during the summer of 2007. Increases in tension and resistance indicate the sediment was drying.

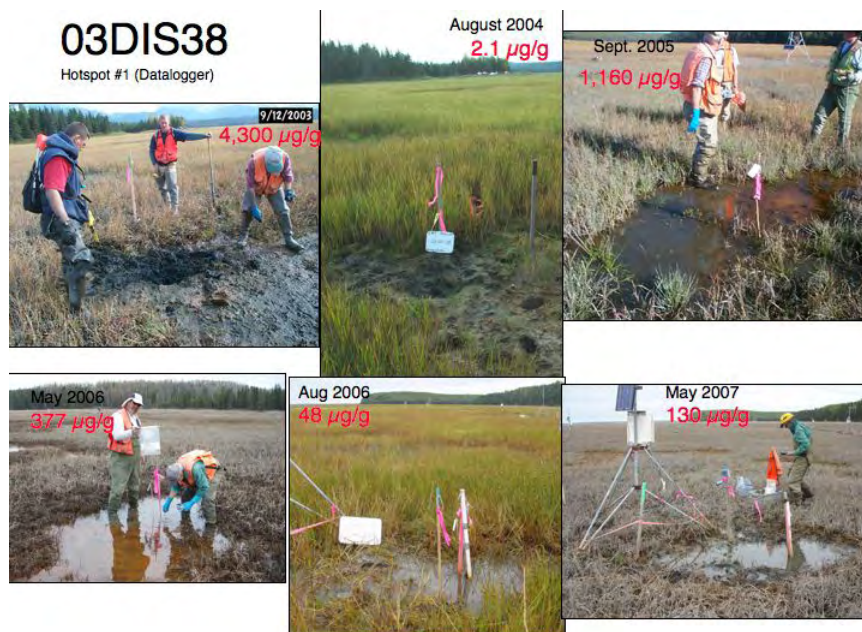
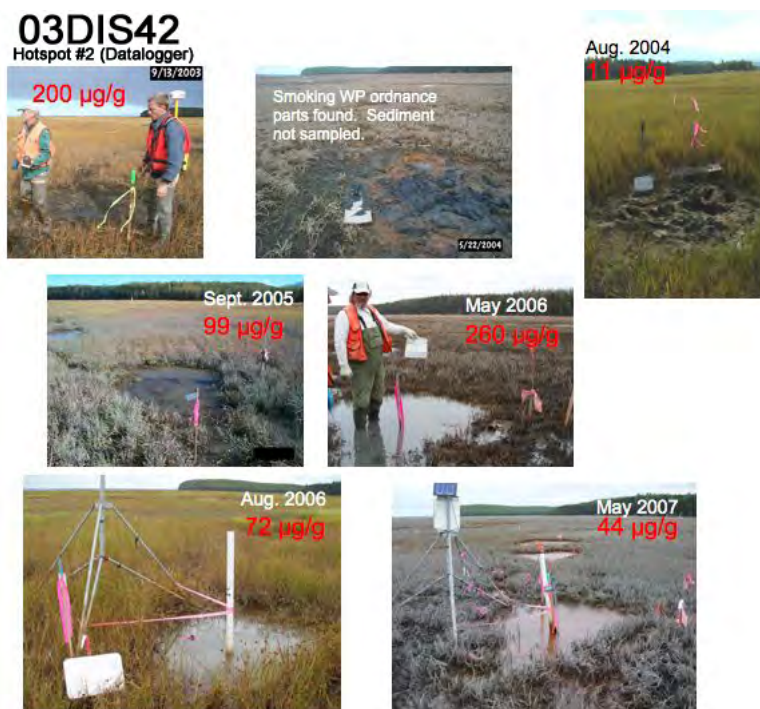
a. 03DIS38.

b. 03DIS42.

Figure III-2-13. Views of pools where samples 03DIS38 and 03DIS42 were collected. Both originally contained WP-filled mortar tail assemblies. The numbers in red are WP concentrations in the surface sediment.

Monitoring stations were placed in two C Marsh pools where WP ordnance scrap was found in 2003 (Fig. III-2-13a). Both locations [03DIS38 (Hotspot#1) and 03DIS42 (Hotspot#2)] had high concentrations of WP in 2003 (4300 and 204 $\mu\text{g/g}$, respectively). Both locations have consistently had concentrations of greater than 1 $\mu\text{g/g}$ in the surface sediments at each sampling event (Fig. III-2-13 and Appendix Table III-2-B3). The May 2007 concentrations were 130 and 44 $\mu\text{g/g}$, respectively. Despite the general downward trend in WP concentrations between May and August samples, which indicates that surface sediments are drying somewhat during the summer, there is still ample WP to poison waterfowl in these two shallow pools. The moisture sensors in 2007 show that surface sediments of both pools dried only a slight amount (Fig. III-2-10d and III-2-10e). Losses of WP from the planted particles were 55% and 28%, respectively. If these pools were pumped for many, many more years, the surface sediment would eventually decontaminate. Given their small size, capping would be the preferred approach.

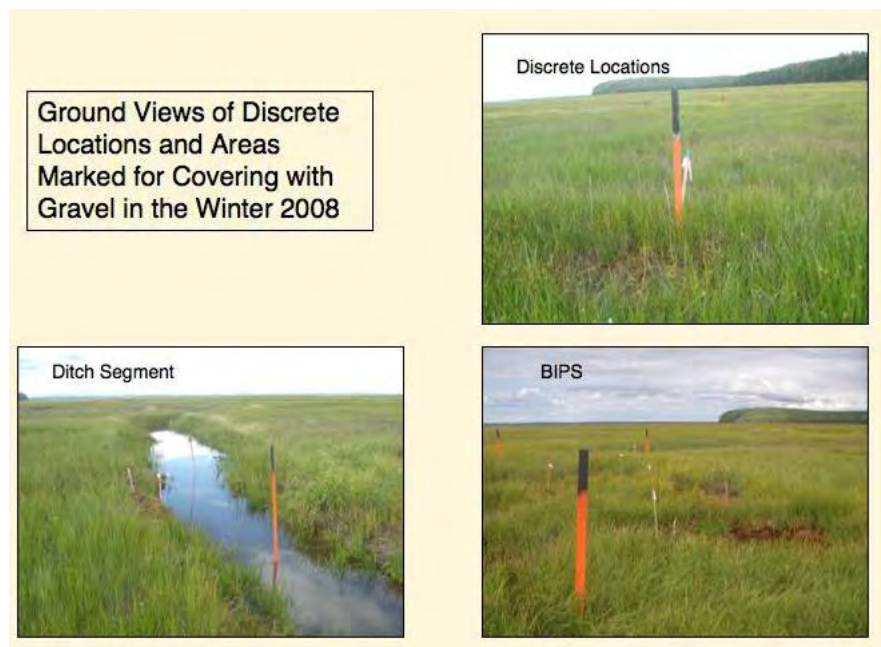
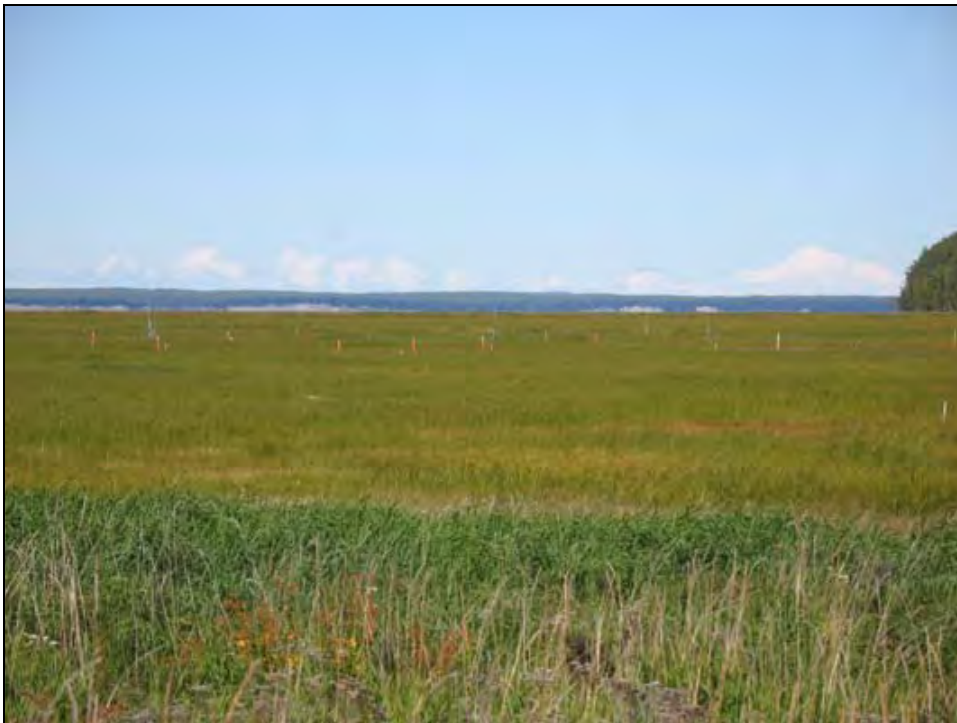
a. Close-up views in August 2007.

b. View across the C Marsh from Clunie Pad.

Figure III-2-14. Orange markers designating points or boundaries of areas to be capped.

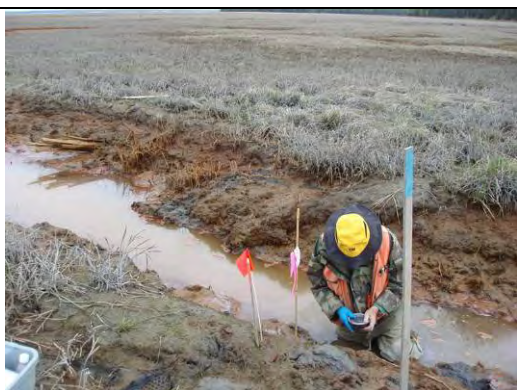
04DIS125 (In Ditch Segment 5: Cross Ditch)

Area marked	04DIS125	355,228	6,801,523	08/25/04	C	at UXO scrap	950	Location of WP fin found in May.
				09/12/05		5 cm	1.71	
				05/23/06		5 cm	84	
				08/30/06		5 cm	<0.0002	Intersection of cross-ditch and south ditch. Location was blasted to deepen ditch on 11 July 2006.

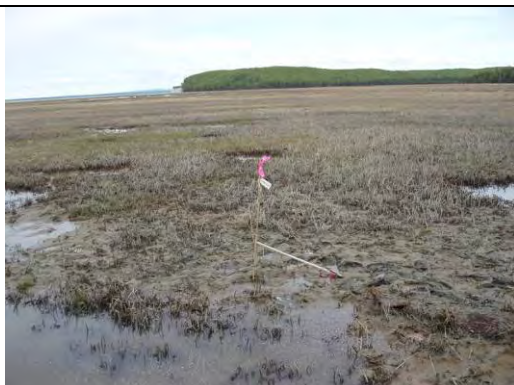
04DIS97 (3-m radius)	354,782	6,801,724	05/15/06		5 cm	<0.0002	3 m from center point
n	04DIS099	354,784	6,801,717	05/26/04	BT	at UXO scrap	17.4	Split mortar round. Buried 66 cm deep.
				05/25/07		0 16cm	0.0073	Sediment from walls and bottom of 16 cm deep hole.
n	04DIS100	354,788	6,801,670	05/26/04	BT	at UXO scrap	21.5	Split mortar round. On 27 May 2004, evidence of burning. WP odor.
n	04DIS101	354,807	6,801,673	05/26/04	BT	at UXO scrap	324	Split mortar round.
				05/25/07		0 5cm	0.0003	Surface sediment of shallow hole.

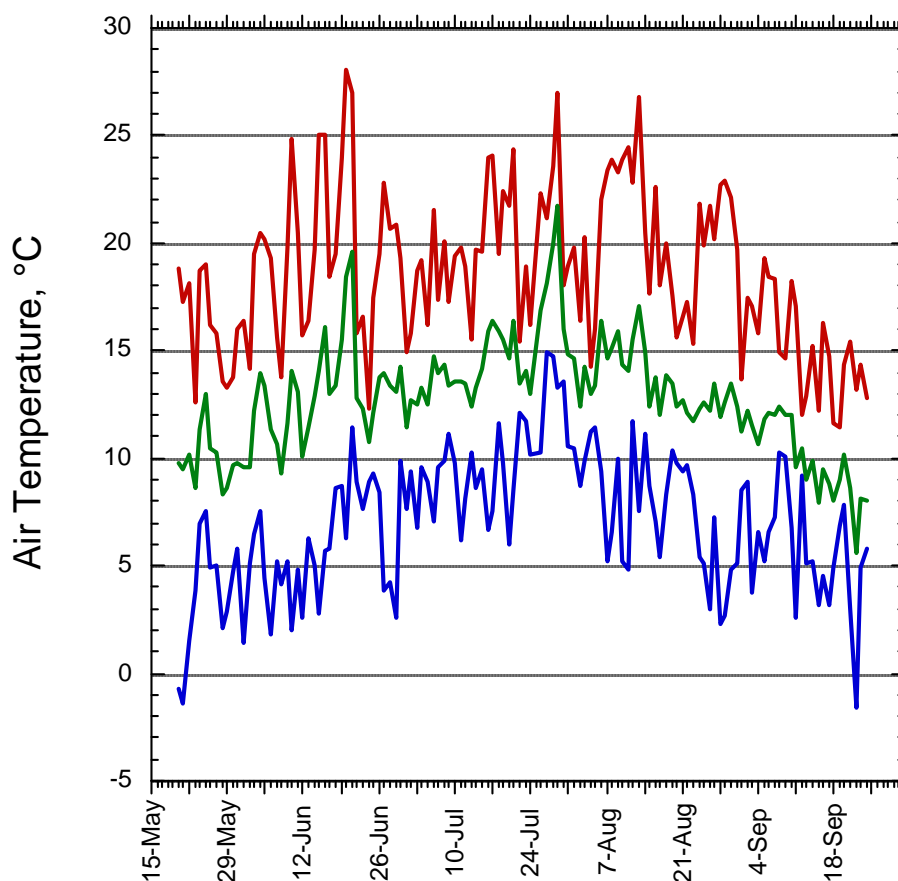
Figure III-3-2. Maximum, minimum, and average air temperatures for the Eagle River Flats meteorological station from May through August 2007 shown in red, blue, and green, respectively. The season had just slightly above normal temperatures with 42 days with maximum temperatures of 20°C or more. The warmest day was 20 June, when the maximum temperature was 28.1°C .

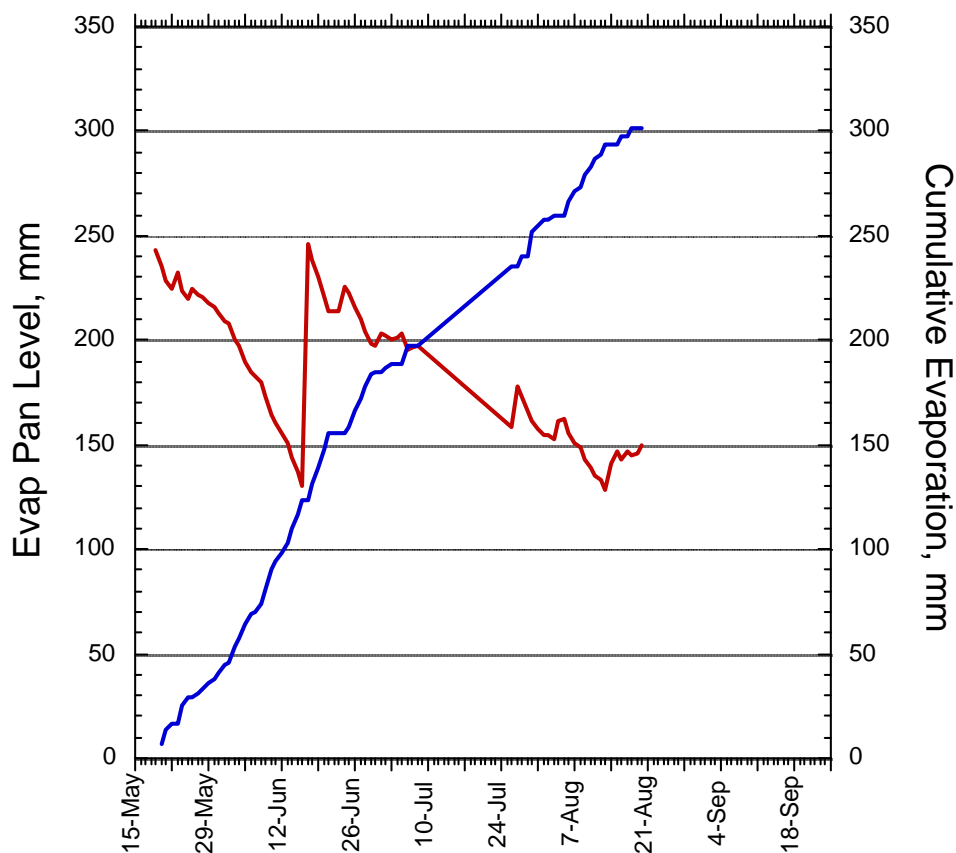
Figure II-3-4. Evaporation pan data showing evaporation pan water level data (red) and net cumulative evaporation for the season (blue). Evaporation rate is consistent over the season, reflecting the normal to slightly above normal temperatures. Pan water levels show decreases due to evaporation, and increases due to addition of make-up water on 17 June.
